DELAWARE RIVER BASIN

SCS PA 477
BERKS COUNTY, PENNSYLVANIA

NDS I.D. NO. PA 00720
DER I.D. NO. 6-457

PHASE I INSPECTION REPORT
NATIONAL DAM INSPECTION PROGRAM

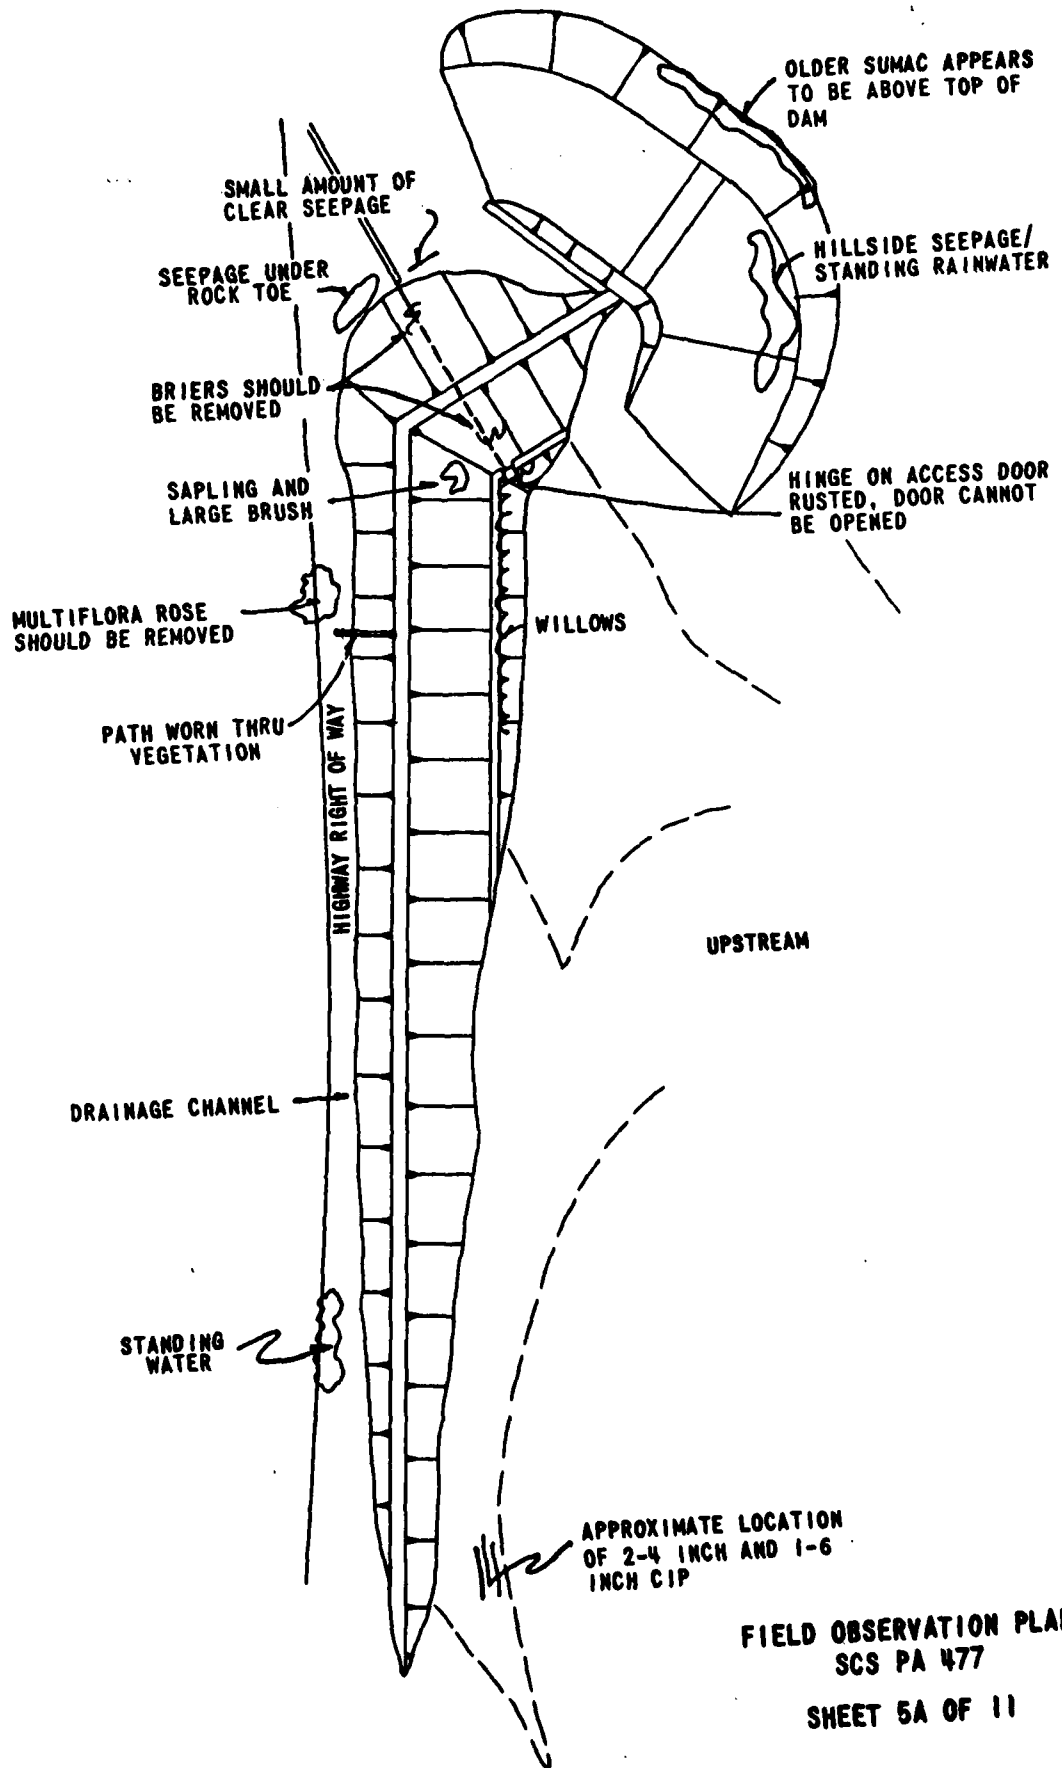
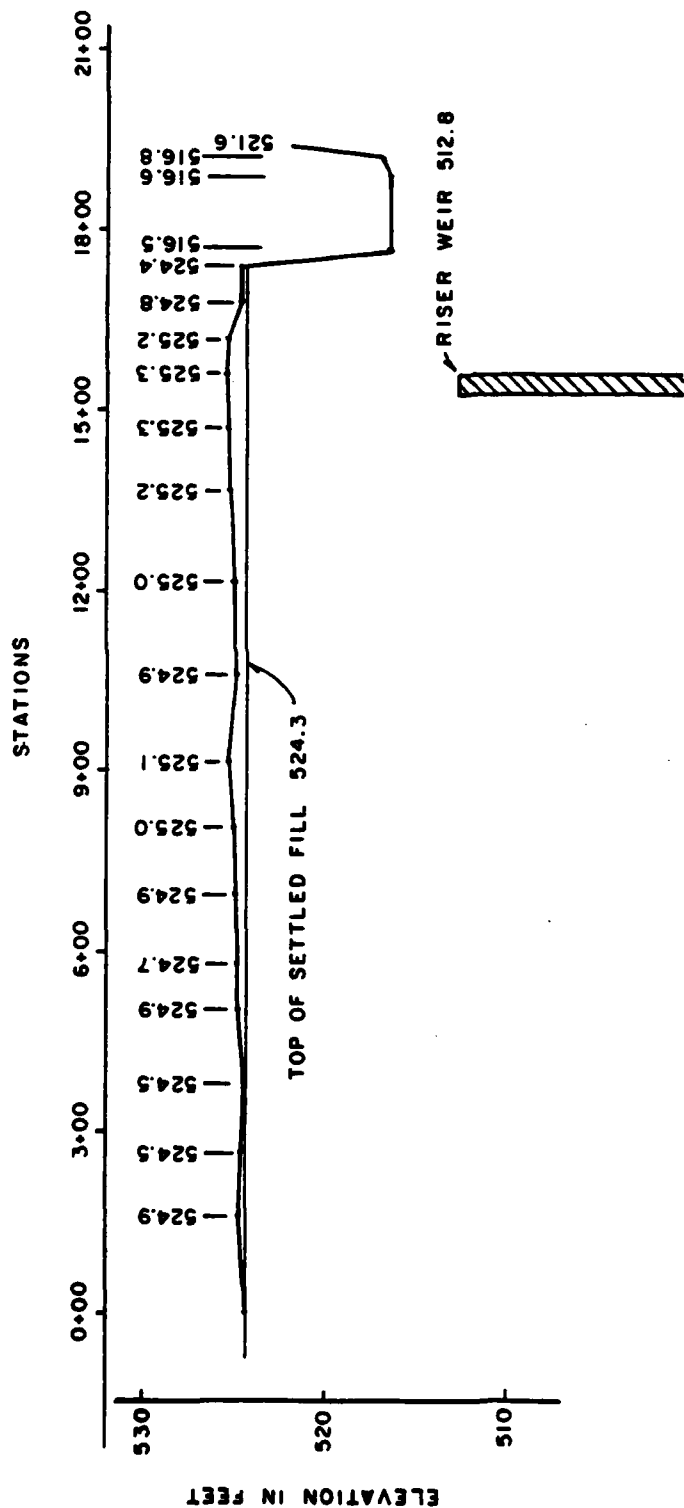
Sheet 5 of 11

VISUAL EXAMINATION OF	OBSERVATIONS	REMARKS OR RECOMMENDATIONS
VEGETATION	<p>Although upstream and downstream slopes have generally a good cover of Grownvetch, brambles and wild roses are beginning to grow, and several three to four year old saplings. All should be removed. There are some spots of poor cover and weeds on the embankment. Willows are growing along the water line on the embankment; although these have been cut, they should be removed by a more positive method.</p>	
JUNCTION OF EMBANKMENT AND ABUTMENT, SPILLWAY AND DAM	<p>Good condition.</p>	
ANY NOTICEABLE SEEPAGE	<p>Small amount of clear seepage entering below the water level from the right of the impact basin.</p>	
STAFF GAGE AND RECORDER	<p>None</p>	
DRAINS	<p>No water flowing from embankment drains outletting through impact basin walls.</p>

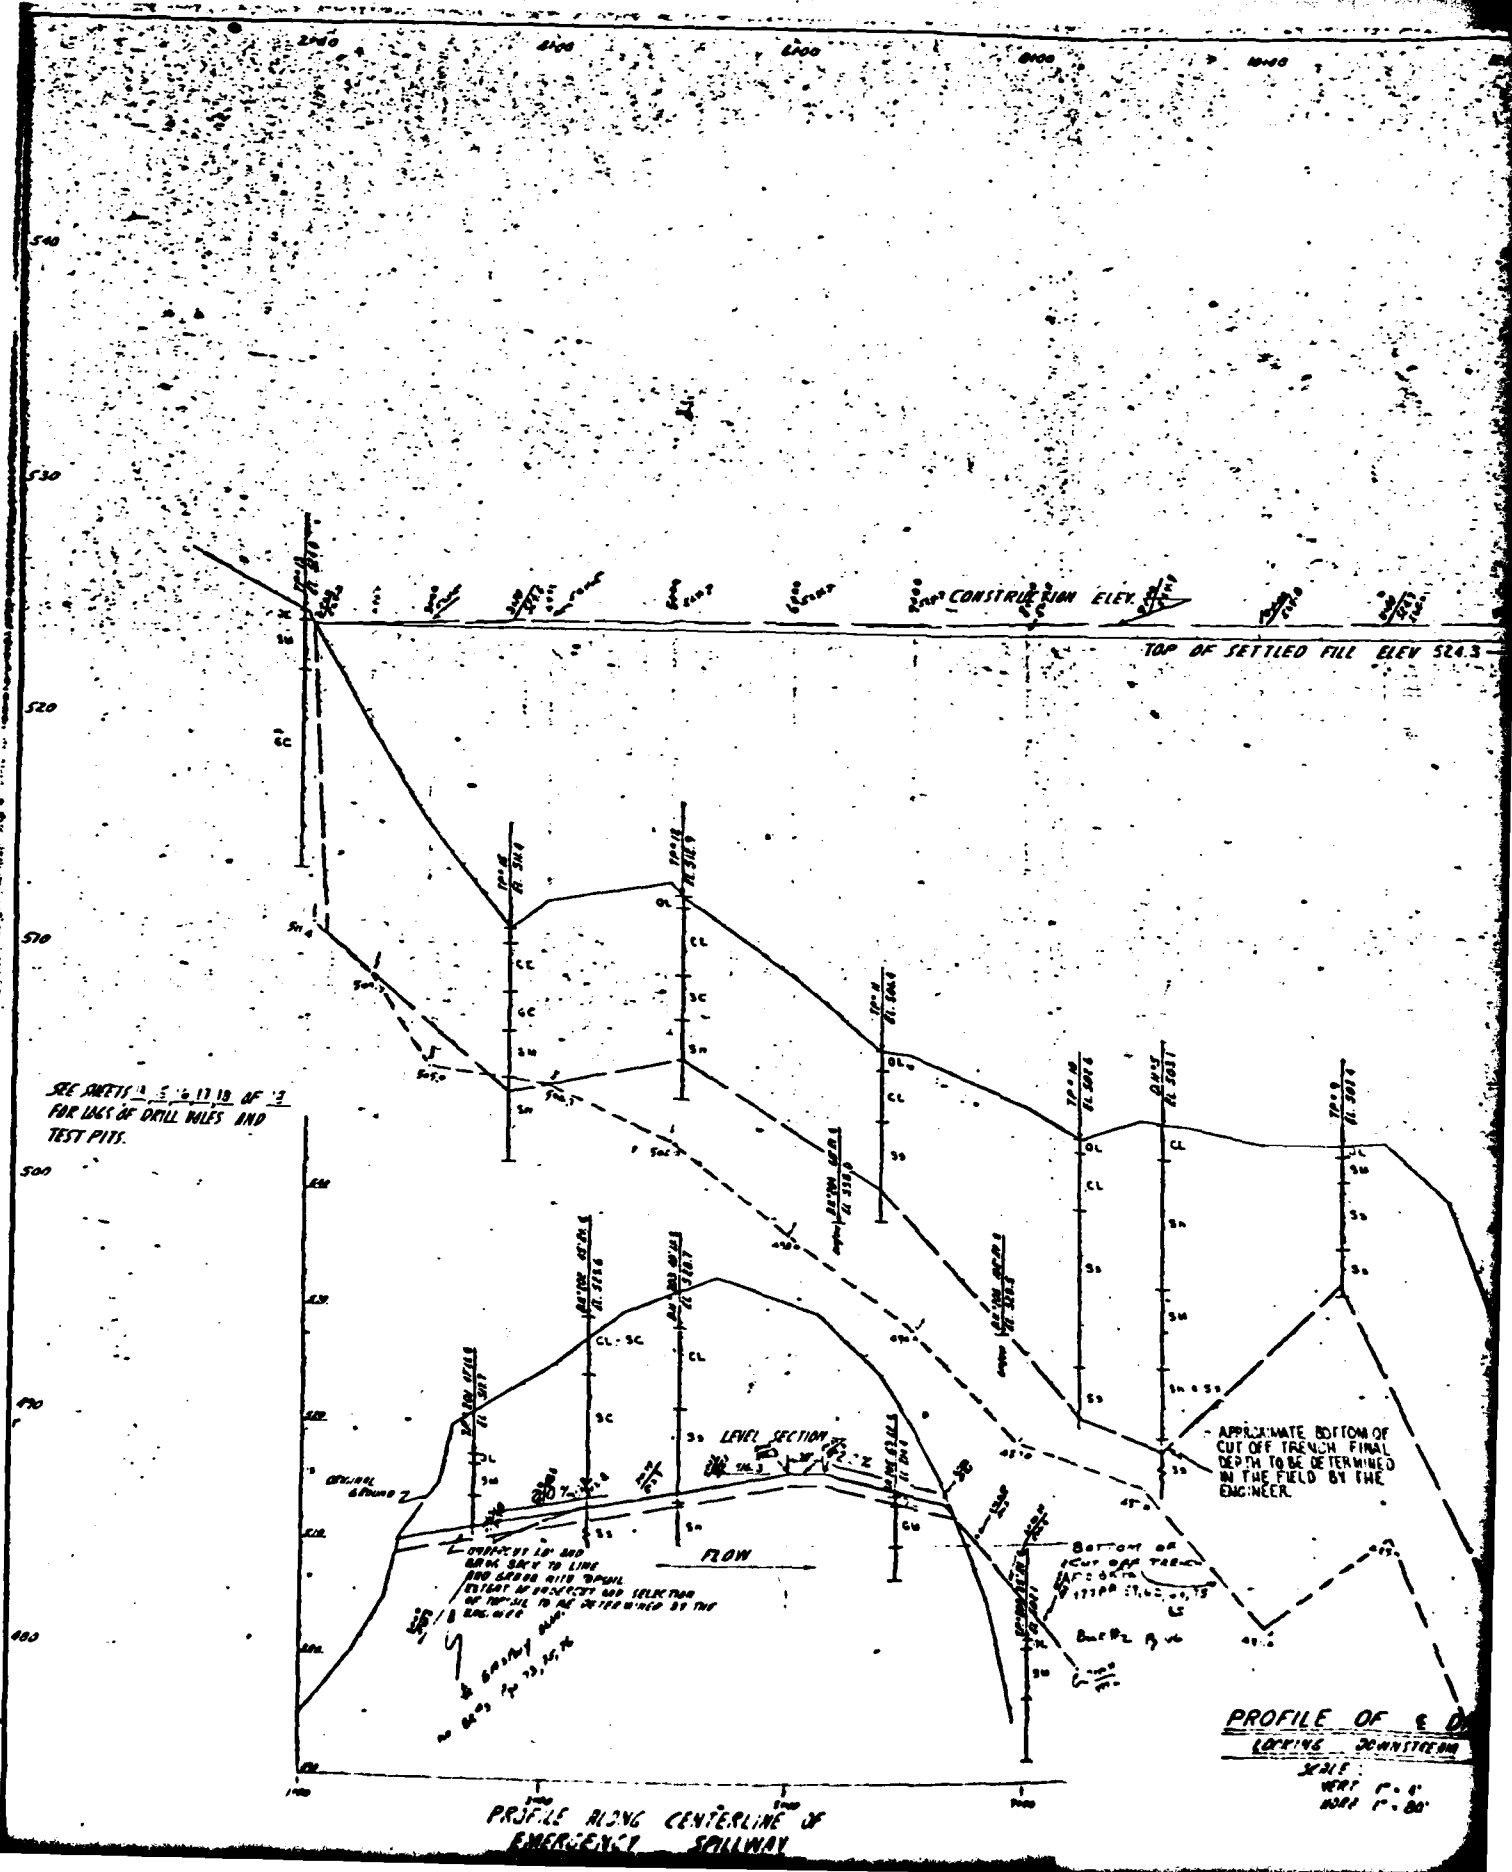
PROFILE ALONG CENTERLINE OF
EMERGENCY SPILLWAY

NOTE: October 26, 1979, Phase 1 Inspection survey disclosed Dam crest elevations to range from 524.4 to 525.3

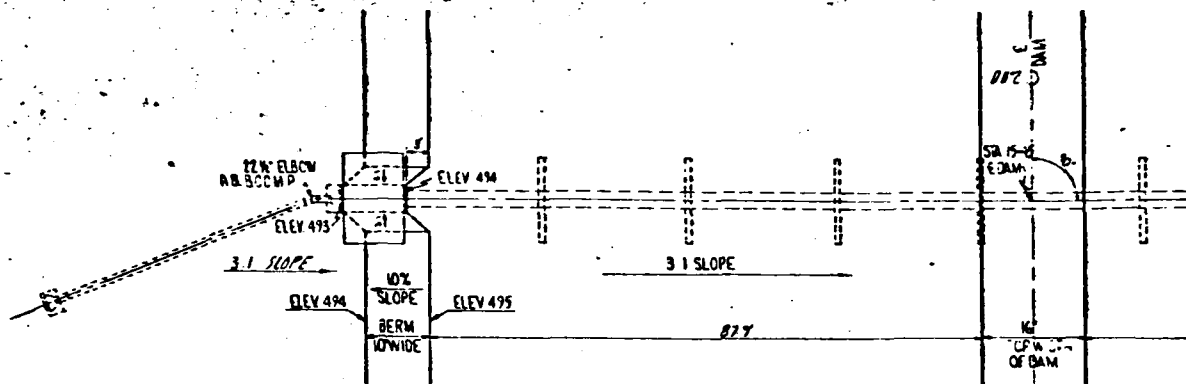
PLAN OF PRINCIPAL SPILL
NOT TO SCALE

NOTE: THIS NUMBER IS 512.8 ON THE DESIGN DRAWING AND
ON PLATE 7
